# **Selected Images of the Effects of the October 15, 2006, Kīholo Bay-Māhukona, Hawai‘i, Earthquakes and Recovery Efforts**

Data Series 506

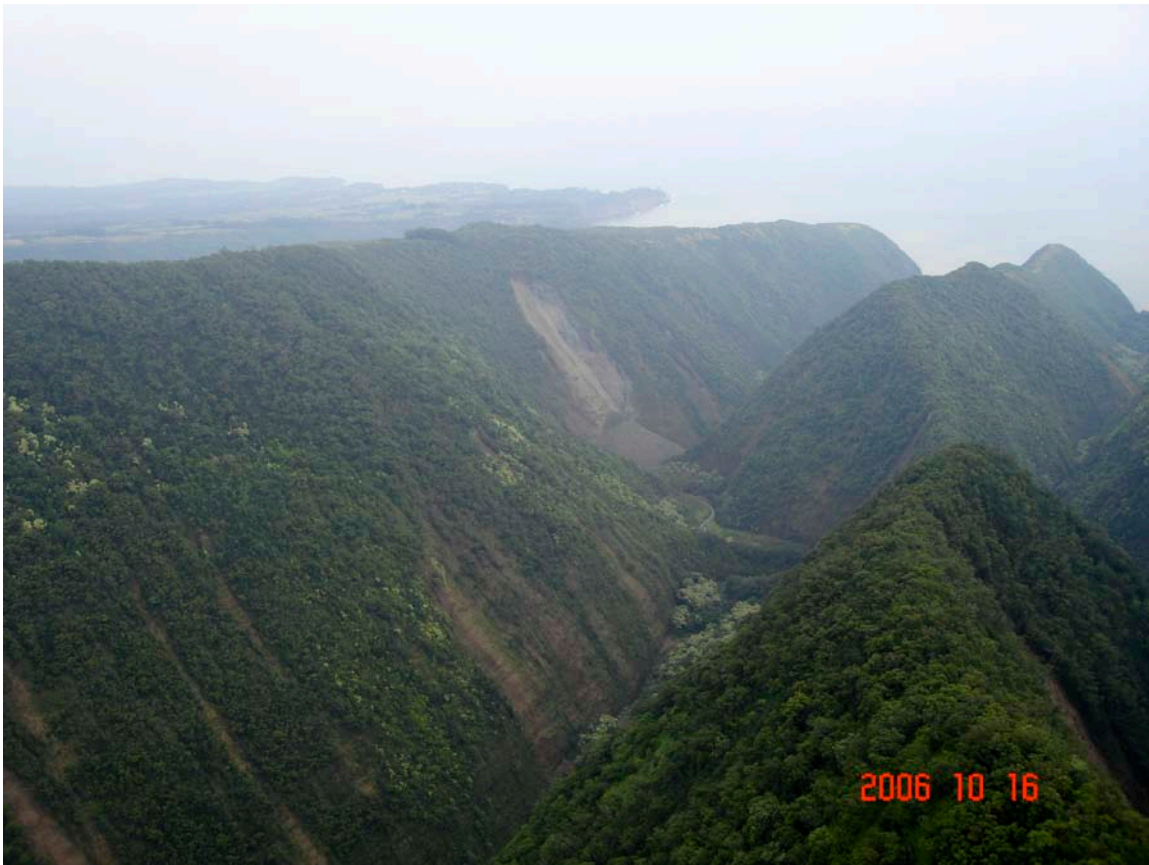
18.3. Broad aerial view of the scarred cliffs of Honokāne Nui Valley, including the large rock slide and talus deposit (in center of image), seen in photos 18.1 (elh1205) and 18.2 (elh1204) (view to the north-northwest). DLNR photo by S. Bergfeld, 10/16/2006 (sb922).

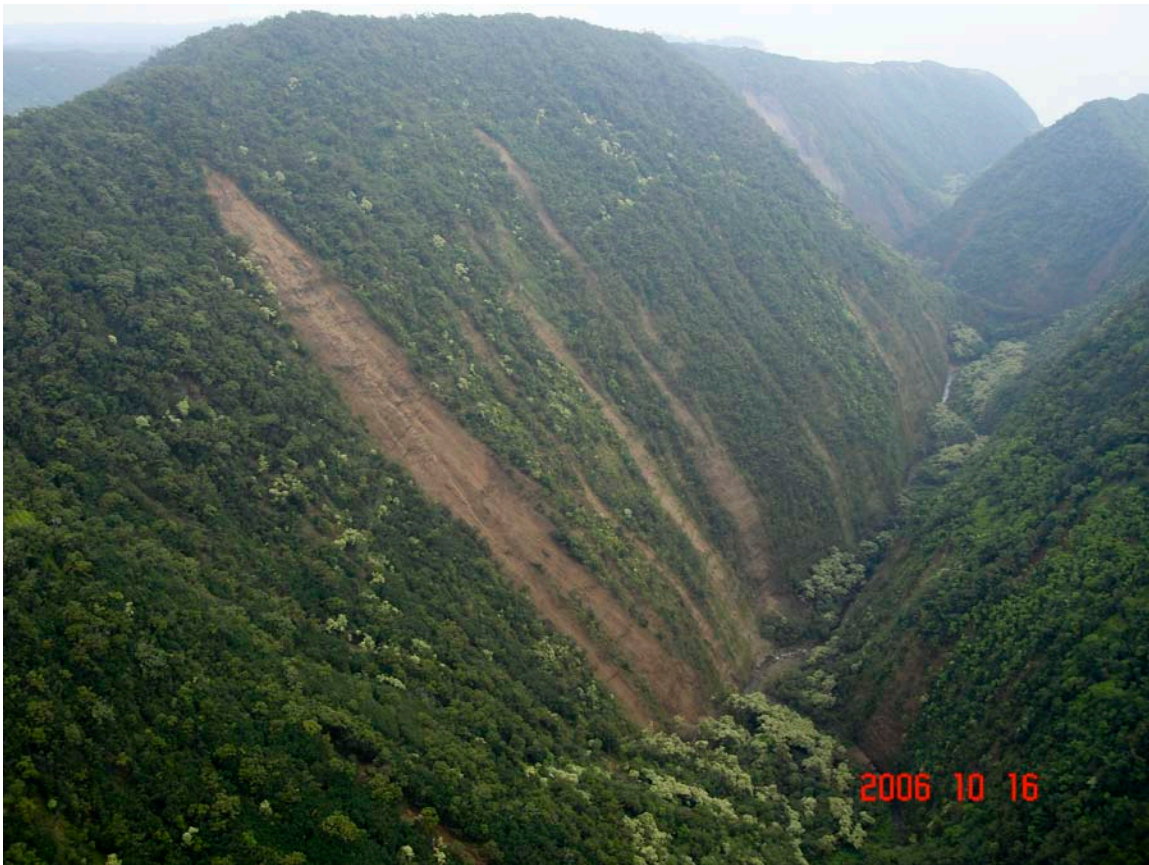
18.4. Close-up aerial view of the long rock slide and numerous other slides that raked across the eastern wall of Honokāne Nui Valley. The large rock slide seen in photos 18.2 (elh1204) and 18.3 (sb922) is partially visible, right of center, in the image (view to the north) farther down the valley. DLNR photo by S. Bergfeld, 10/16/2006 (sb921).

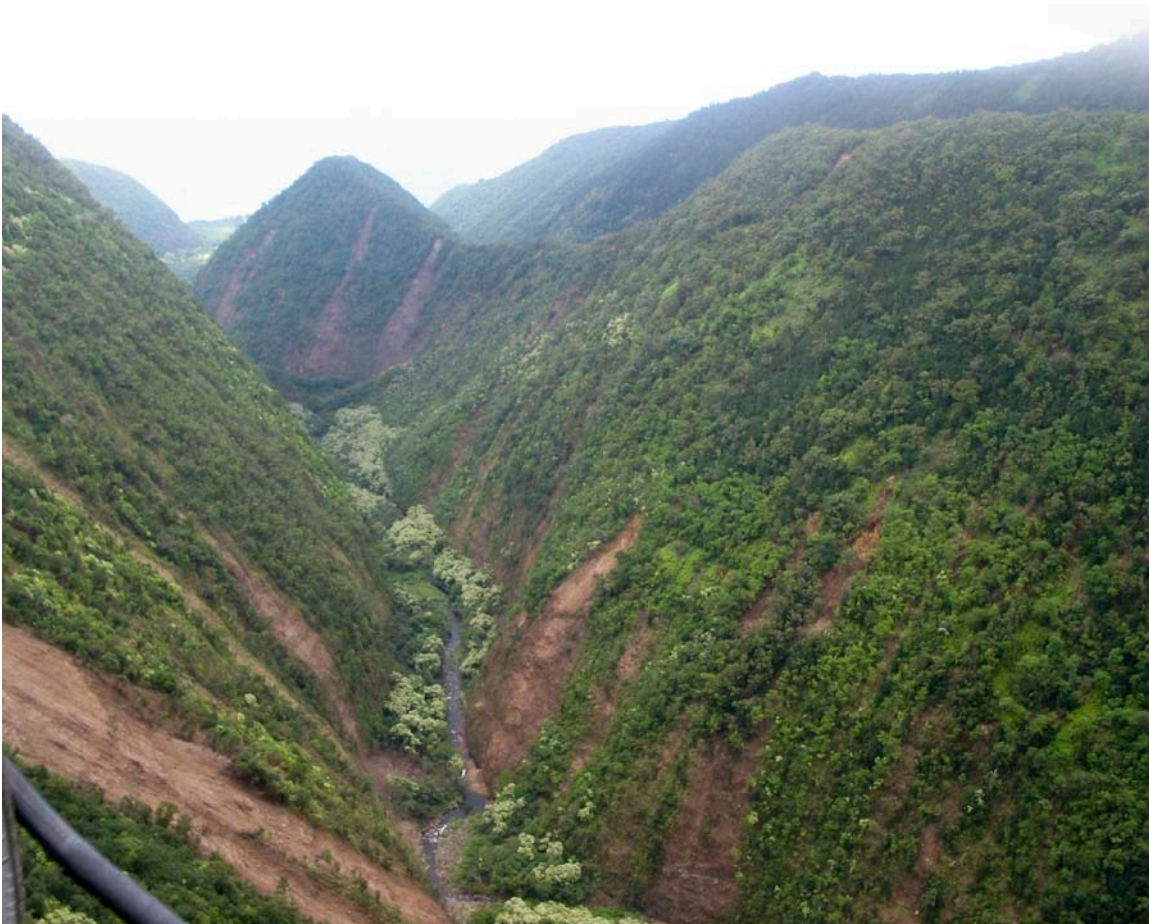
18.5. Aerial view of the extensive series of rock slides across the eastern and western walls of Honokāne Nui Valley. The ridge in the center divides Honokāne Nui and Honokāne Iki valleys. Part of the long rock slide seen in photo 18.4 (sb921) is visible in the lower left foreground (to the right of the aircraft) in this image (view to the north-northwest). USGS photo by J.P. Kauahikaua, 11/8/2006 (jpk6020).

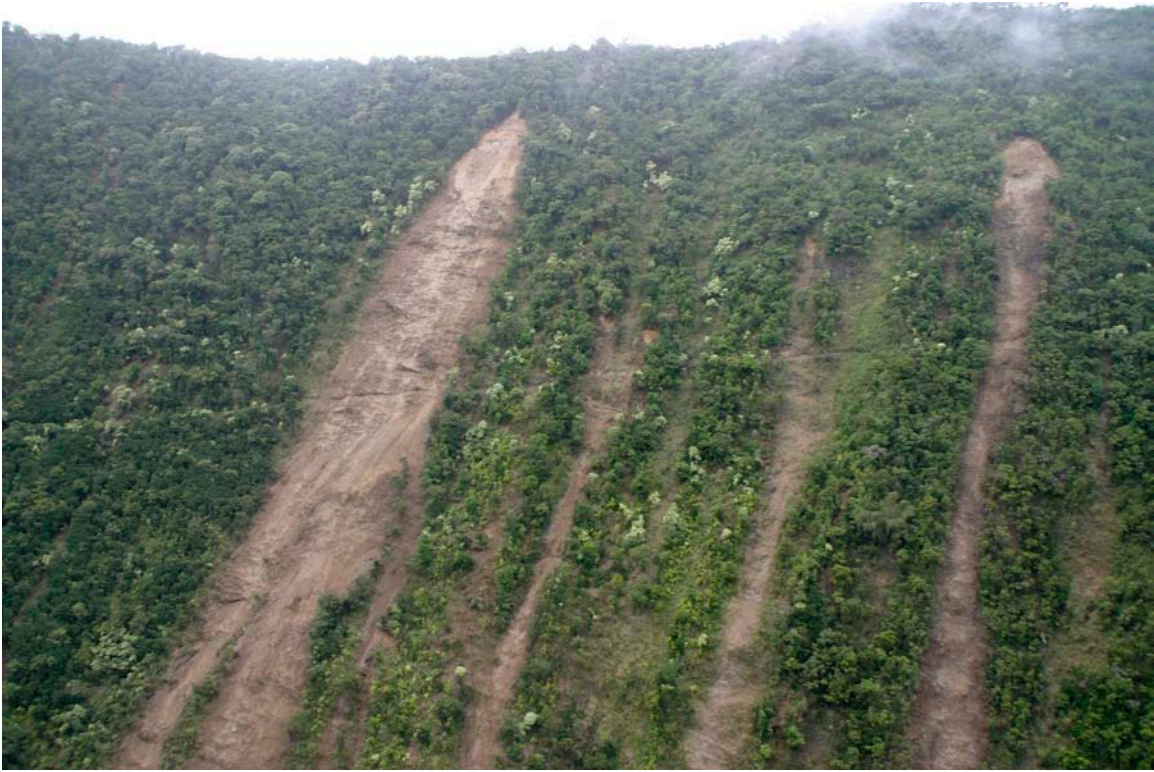
18.6. Close-up aerial view of the trail (light diagonal line), damaged by rock slides and debris, in the lower part of Honokāne Nui Valley approximately 1.6 km (1 mi), south of the massive rock slide seen in photo 18.1 (elh1205) (view to the west-northwest). USGS photo by R.W. Jibson, 11/8/2006 (rwj160).

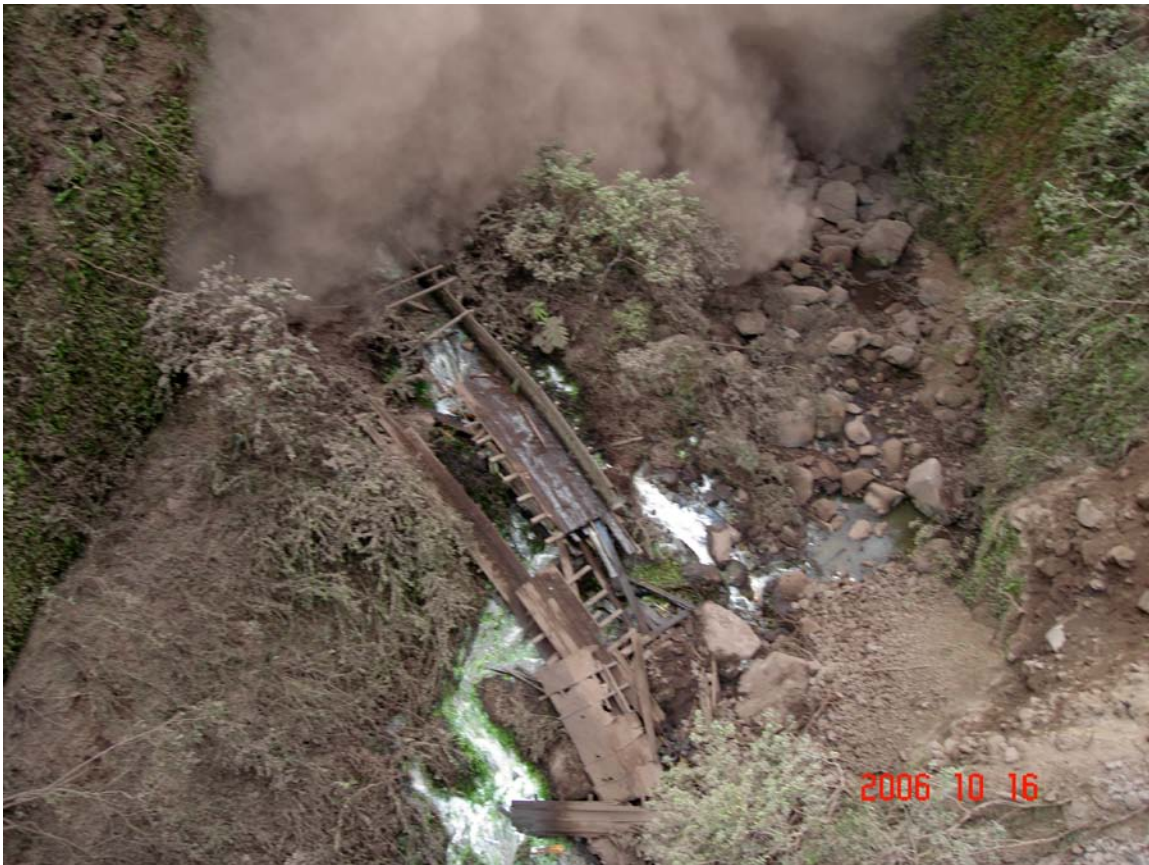
18.8. Vertical aerial view of the dust cloud, rising from a rock fall that has just occurred near a collapsed section of flume in the East Branch of Honokāne Nui Valley. DLNR photo by S. Bergfeld, 10/16/2006 (sb899).

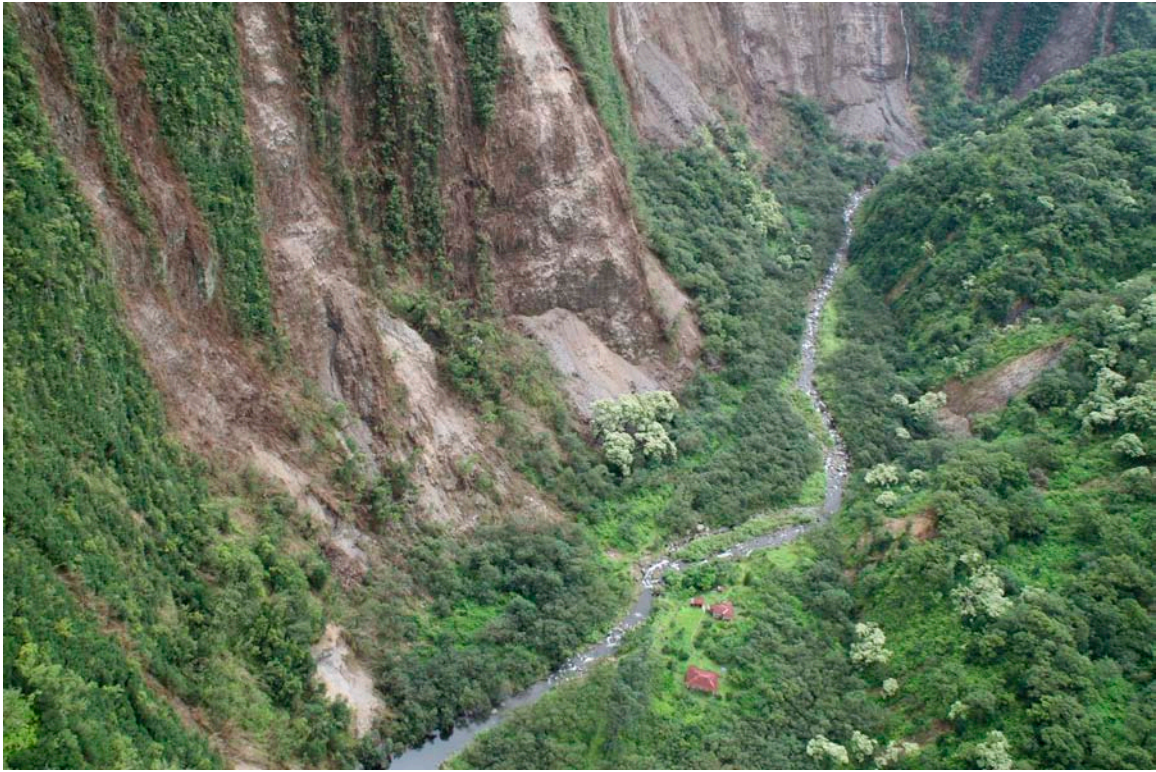
18.9. Aerial view of the floor of the East Branch of Honokāne Nui Valley, littered by rock falls and debris. The old Boy Scout Camp (structures with red roof in the foreground), situated just above the mouth of the East Branch of the valley, survived the onslaught of the debris, which stopped just short of the stream (view to the south-southeast). USGS photo by E.L. Harp, 11/8/2006 (elh1210).

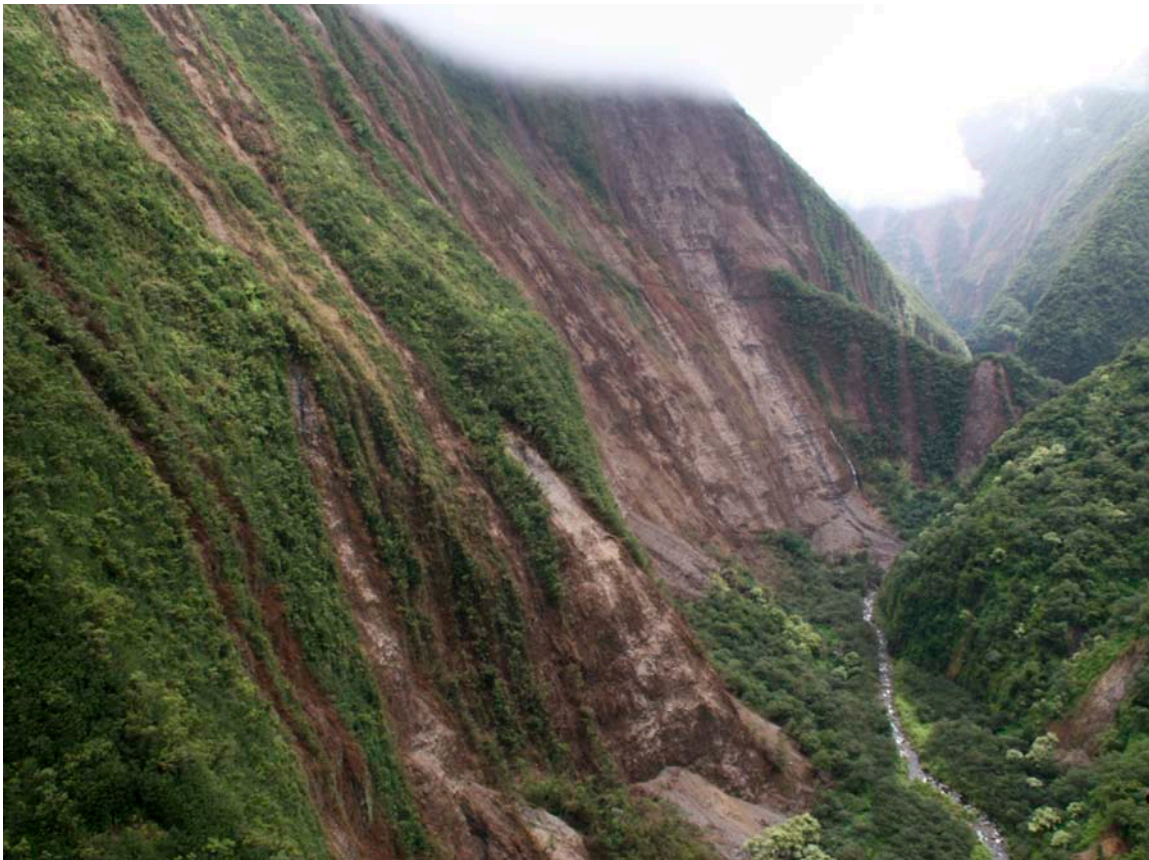
18.10. Aerial view of the Kohala Ditch Trail system (faint zigzag lines two-thirds of the way up the bare wall), inundated by rock-fall debris from the earthquake (view to the south-southeast from the Boy Scout Camp, just out of visual range at the bottom of the photo). USGS photo by E.L. Harp, 11/8/2006 (elh1209).

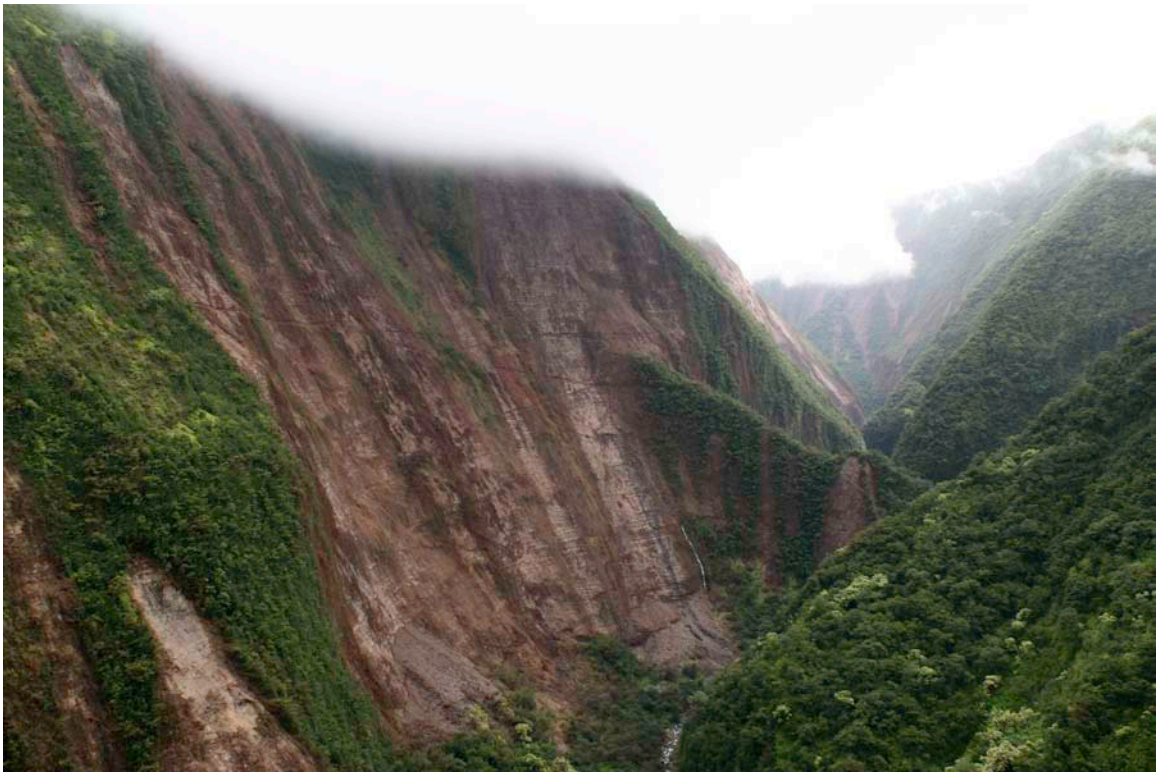
18.11. Close-up aerial view (see also photo 18.10 (elh1209)) of the extensive damage to the Kohala Ditch Trail that zigzags across the now bare walls of the East Branch of Honokāne Nui Valley (view to the southeast). USGS photo by E.L. Harp, 11/8/2006 (elh1211).

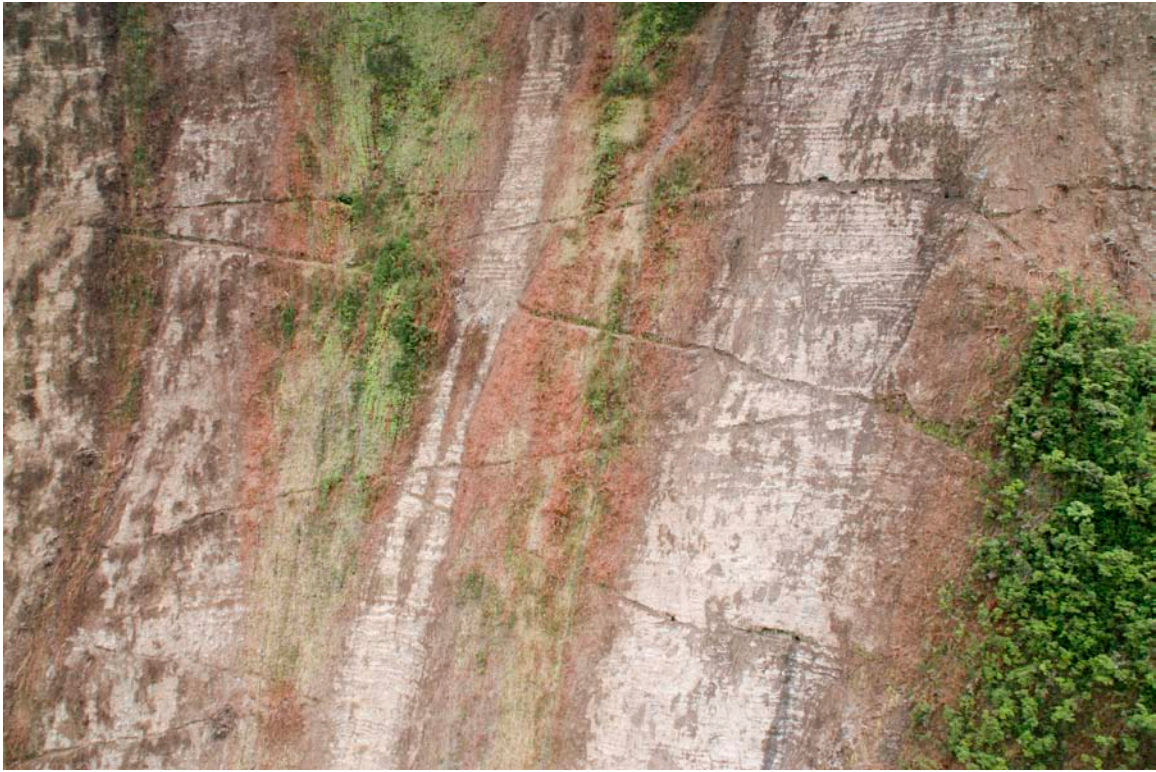
18.12. Close-up aerial view (see also photos 18.10 (elh1209) and 18.11 (elh1211)) of the Kohala Ditch Trail, damaged by rock slides, in the East Branch of Honokāne Nui Valley (view to the south-southwest). USGS photo by E.L. Harp, 11/8/2006 (elh1230).

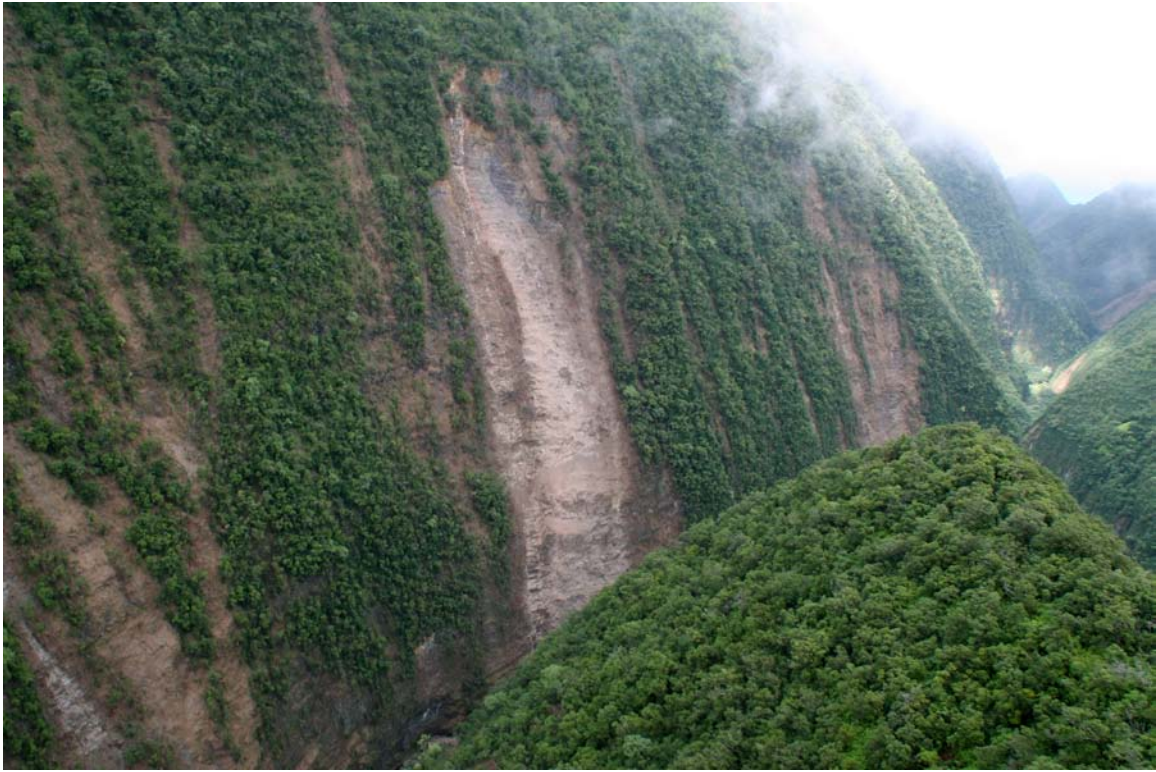
18.14. Close-up aerial view of rock slides that scraped the walls along the West Branch of Honokāne Nui Valley (view to the northeast). USGS photo by E.L. Harp, 11/8/2006 (elh1226).

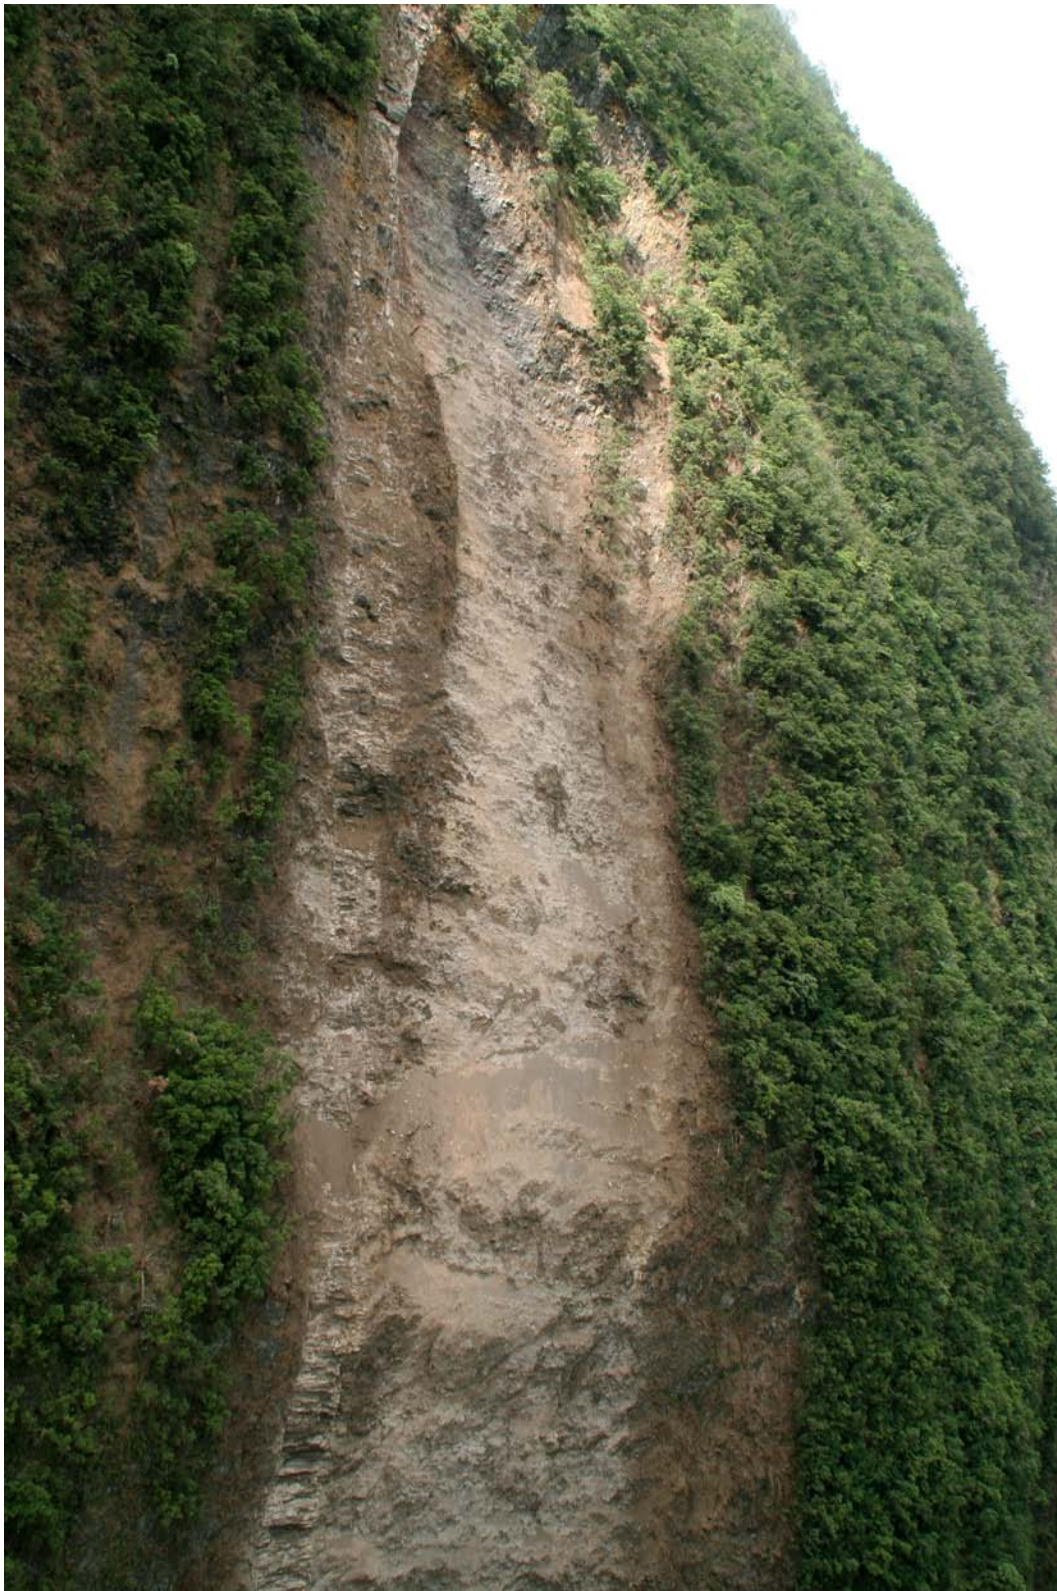
18.15. Close-up aerial view of the rock-fall scar in photo 18.14 (elh1226) at the head of the West Branch of Honokāne Nui Valley (view to the northwest). USGS photo by E.L. Harp, 11/8/2006 (elh1221).

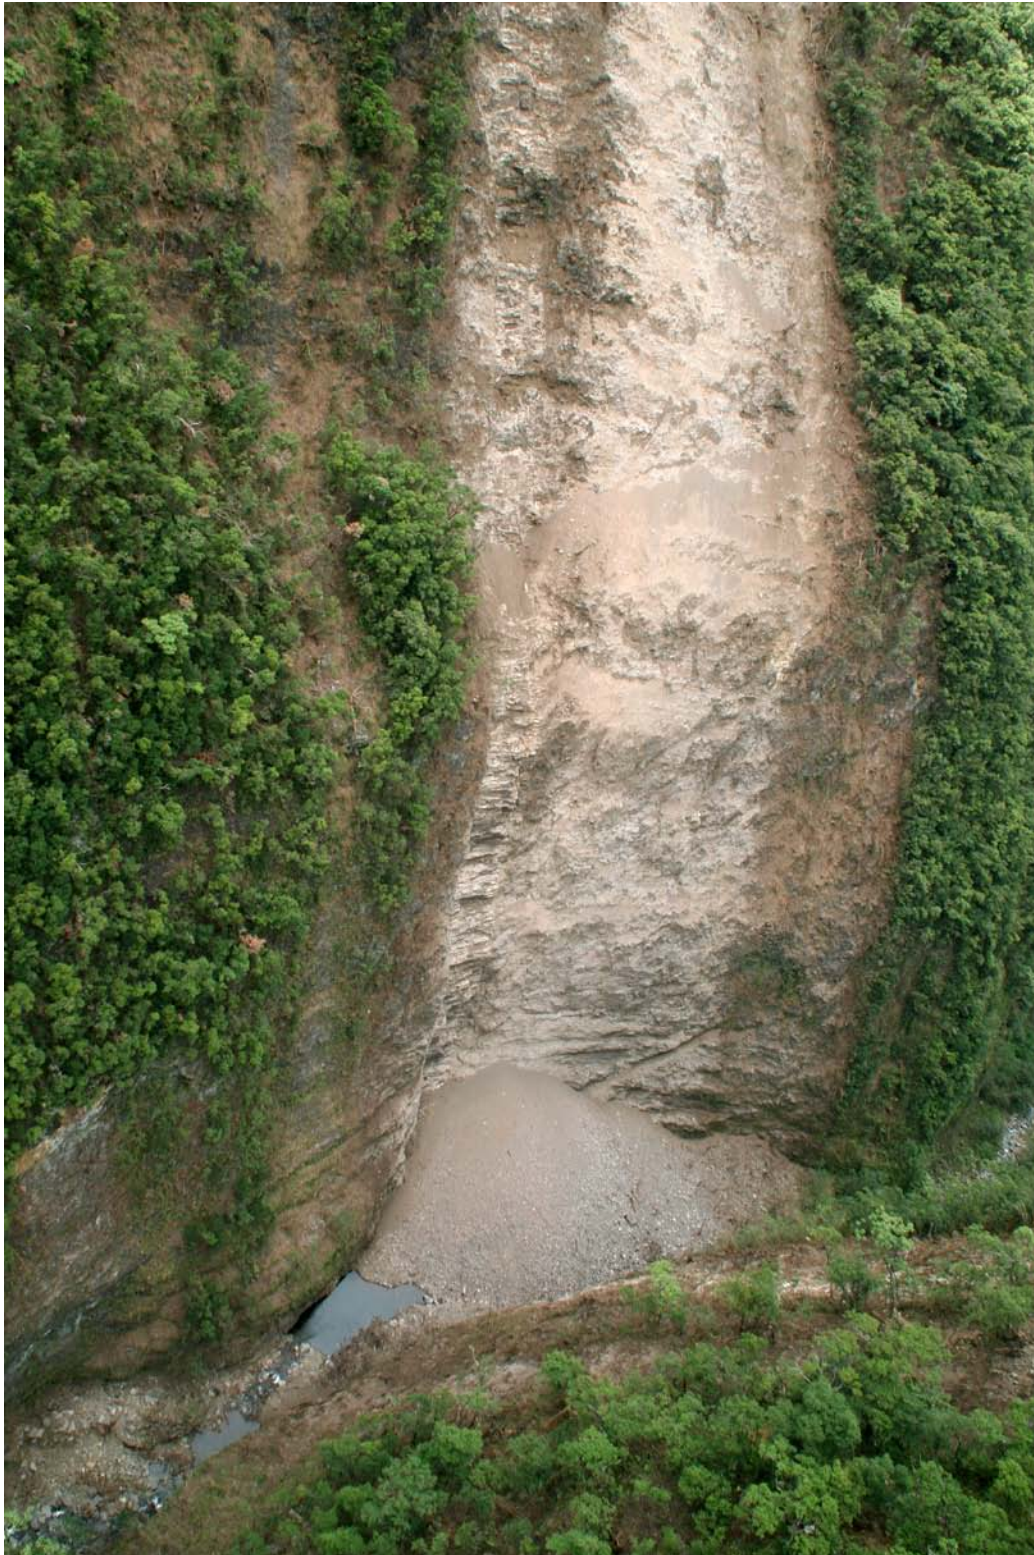
18.16. Aerial view of the base of the rock-fall scar and its talus deposit, which blocked the flow of a stream in the West Branch of Honokāne Nui Valley (see also photos 18.14 (elh1226) and 18.15 (elh1221); view to the northwest). USGS photo by E.L. Harp, 11/8/2006 (elh1220).

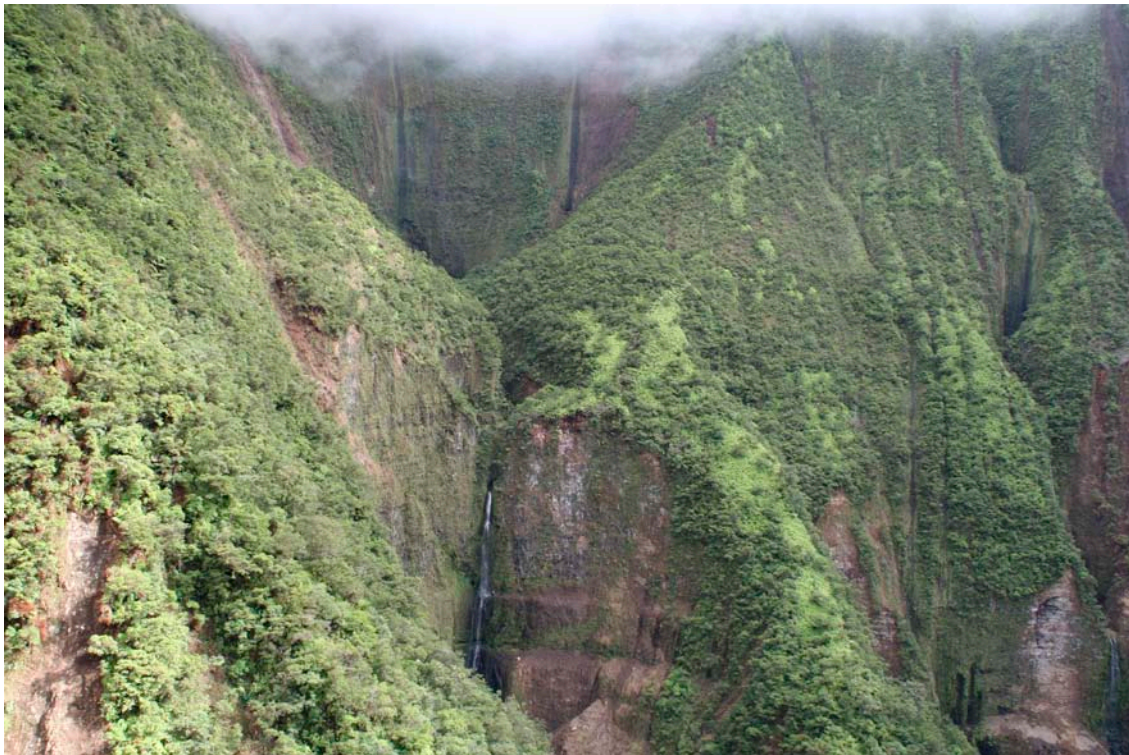
18.17. Aerial view of the waterfalls and rock slides near the head of the East Branch of Honokāne Nui Valley (view to the south-southeast). USGS photo by E.L. Harp, 11/8/2006 (elh1235).

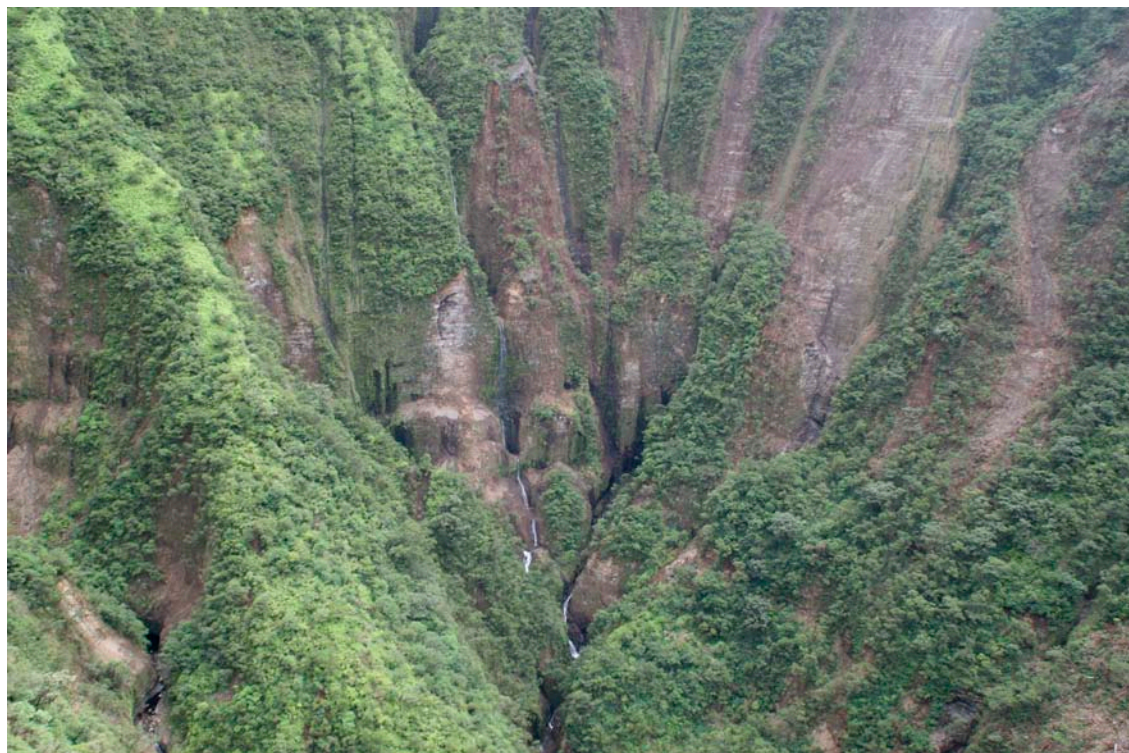
18.18. Aerial view of the sheared walls, cut by streams of cascading water, near the head of the East Branch of Honokāne Nui Valley (view to the south). USGS photo by E.L. Harp, 11/8/2006 (elh1236).

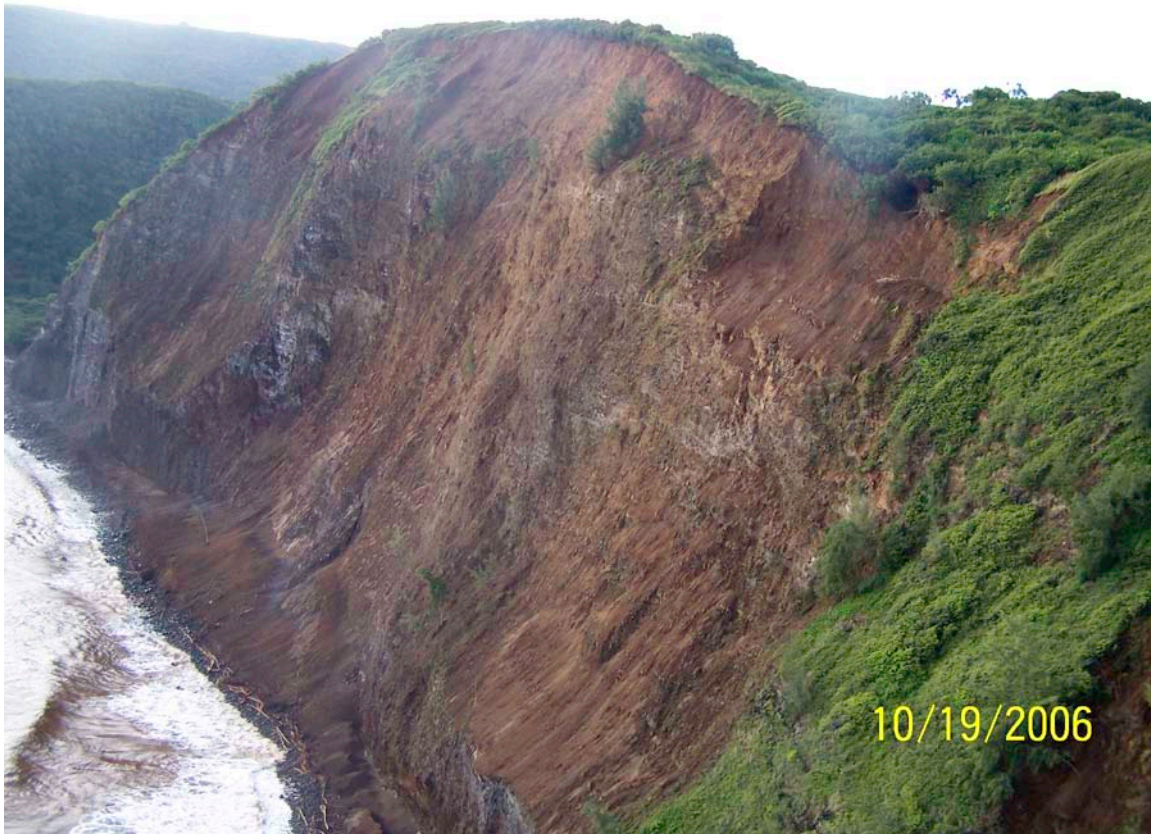
19.1. Close-up aerial view of extensive coalescing rock falls and slides near the entrance of Honokāne Nui Valley along Kohala's northeast coast. Note stripped trees along the shoreline (view to the southeast, just northeast of the Pololū Valley entrance). DLNR photo by K. Gooding, 10/19/2006 (kg1441).

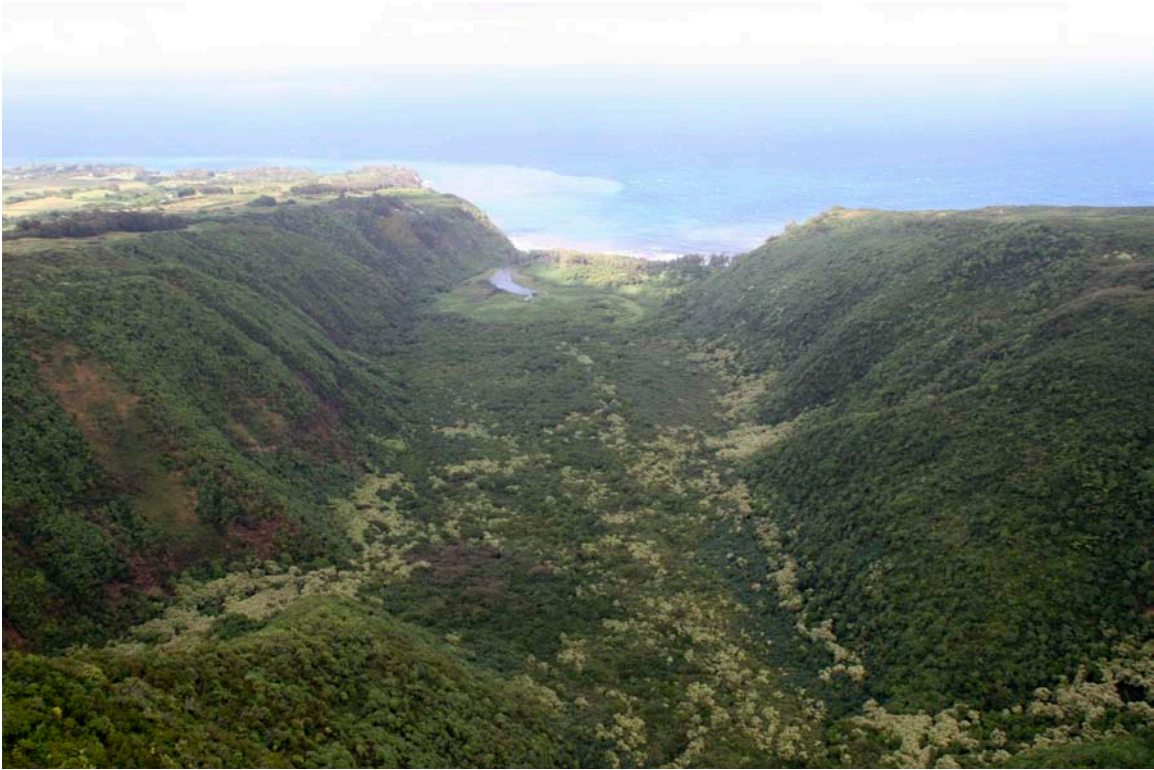
19.4. Aerial overview of the floor and rock falls along the cliffs on the west (windward) side of Pololū Valley (view to the northeast). USGS photo by E.L. Harp, 11/8/2006 (elh1255).

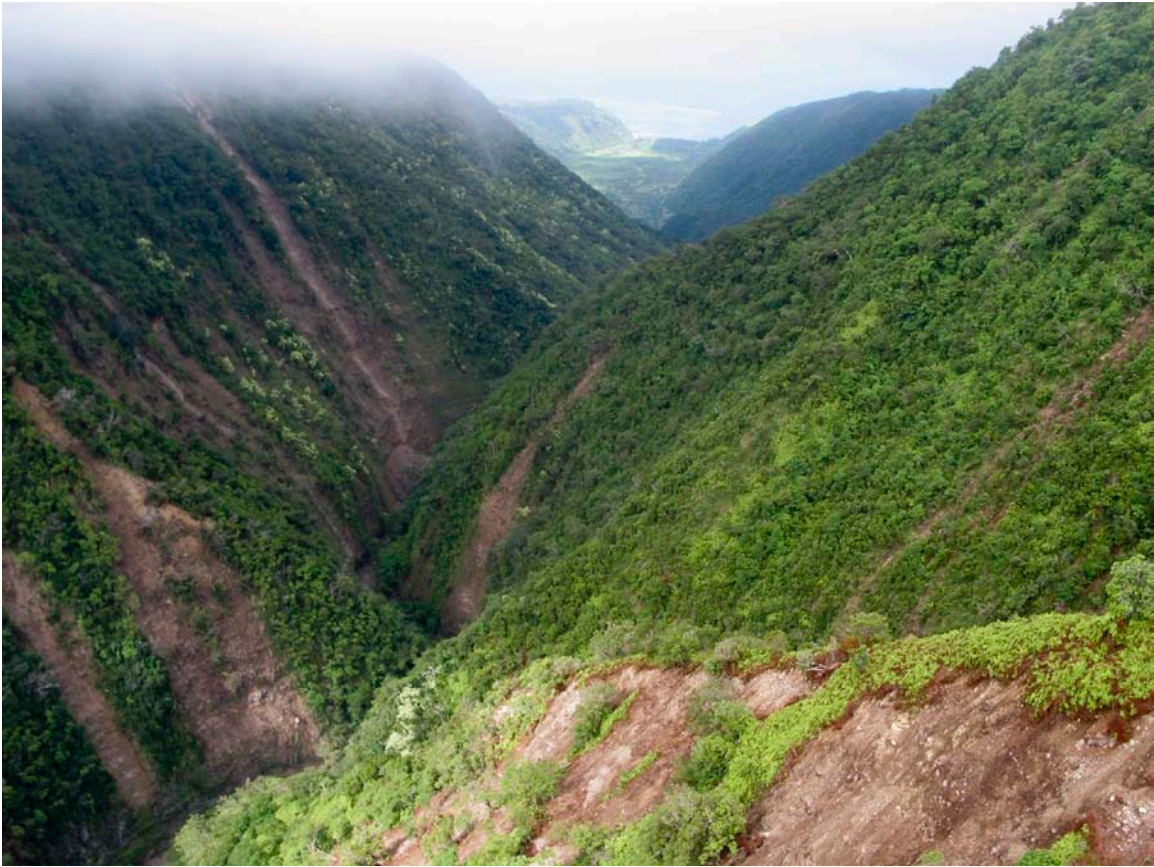
19.5. Aerial view of the extensive rock falls in Pololū Valley. The broad plain and front of the valley can be seen in the distance. Part of the southern slope of a knife-like ridge (see photos 19.6 (elh1247), 19.7 (rwj216), and 19.8 (elh1245)) is visible in the right foreground of this photo (view to the northeast). USGS photo by J.P. Kauahikaua, 11/8/2006 (jpk6031).

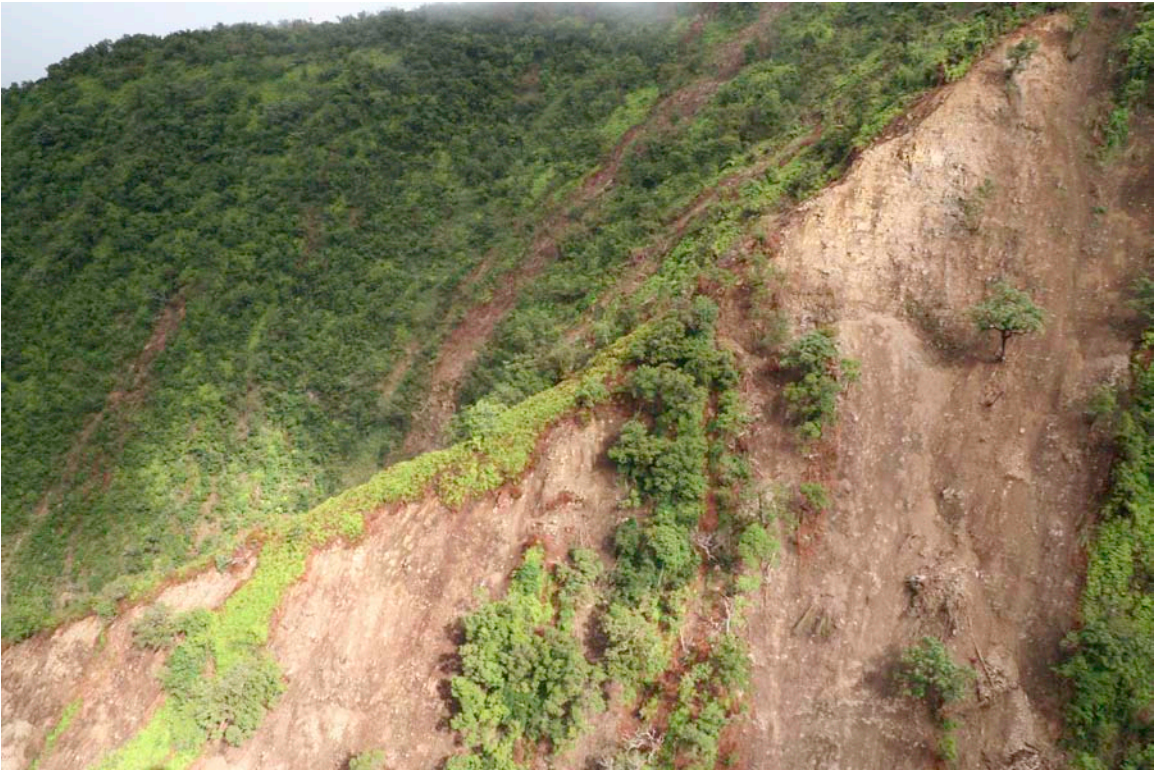
19.6. Close-up aerial view of a knife-like ridge, its vegetation diminished by rock falls, in Pololū Valley (view to the north-northeast). USGS photo by E.L. Harp, 11/8/2006 (elh1247).

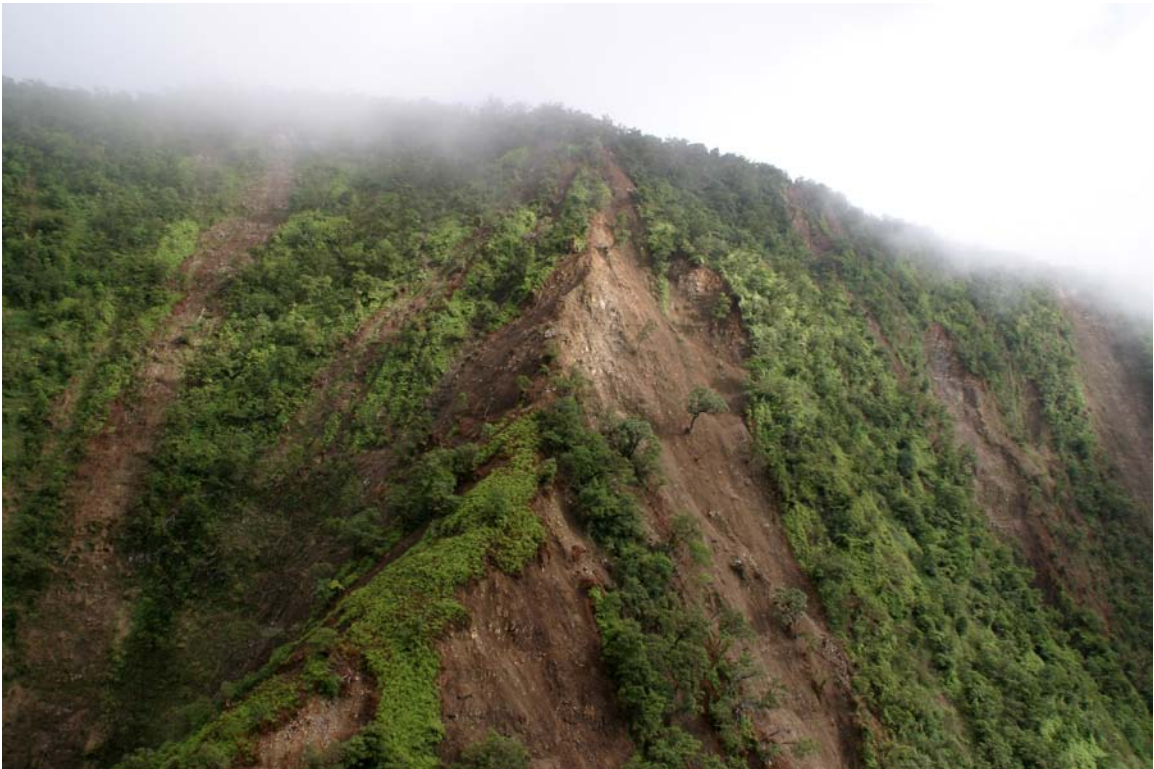
19.7. Close-up aerial view (looking up the axis, to the east) of rock-slide damage on both sides of the knife-like ridge in Pololū Valley (see photo 19.6 (elh1247)). USGS photo by R.W. Jibson, 11/8/2006 (rwj216).

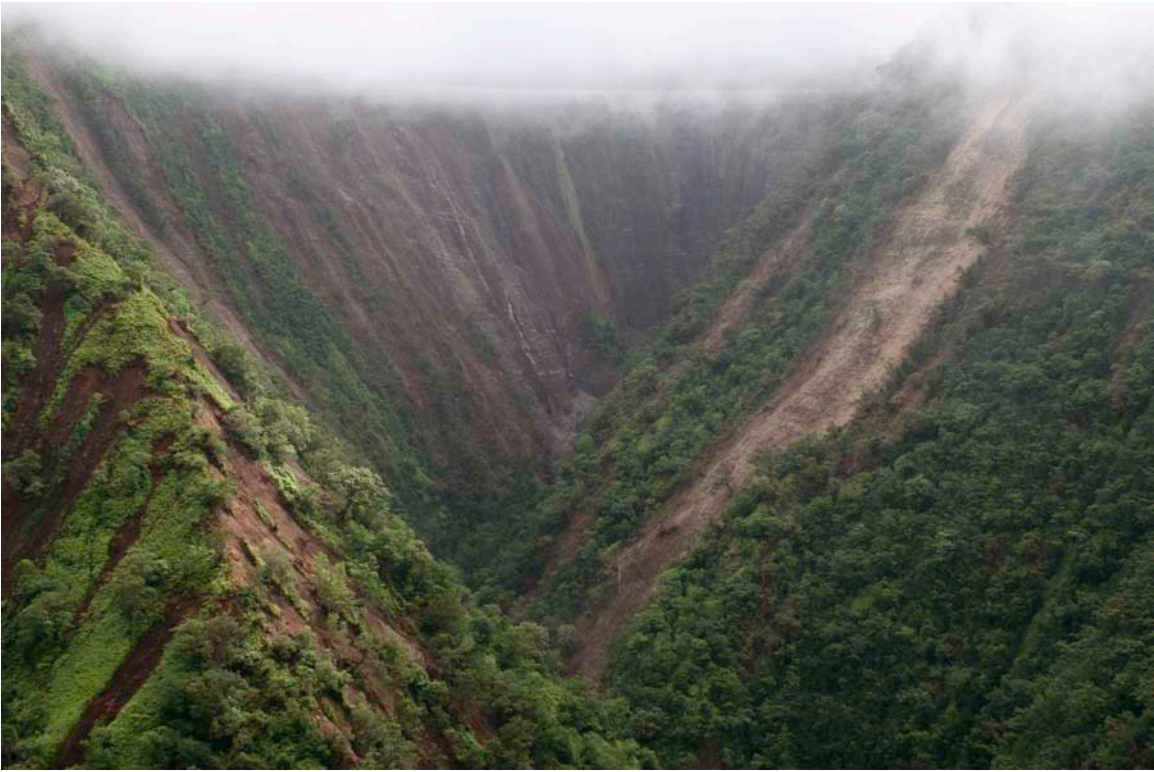
19.9. Close-up aerial view of damage along cliff walls by numerous rock slides at the head of Pololū Valley (see photo 19.8 (elh1245)). The knife-like ridge described in the previous three images is in the left foreground of this photo; in the background is a broad swath of cliffs extensively scrubbed of vegetation by rock falls (view to the south-southwest). USGS photo by E.L. Harp, 11/8/2006 (elh1246).

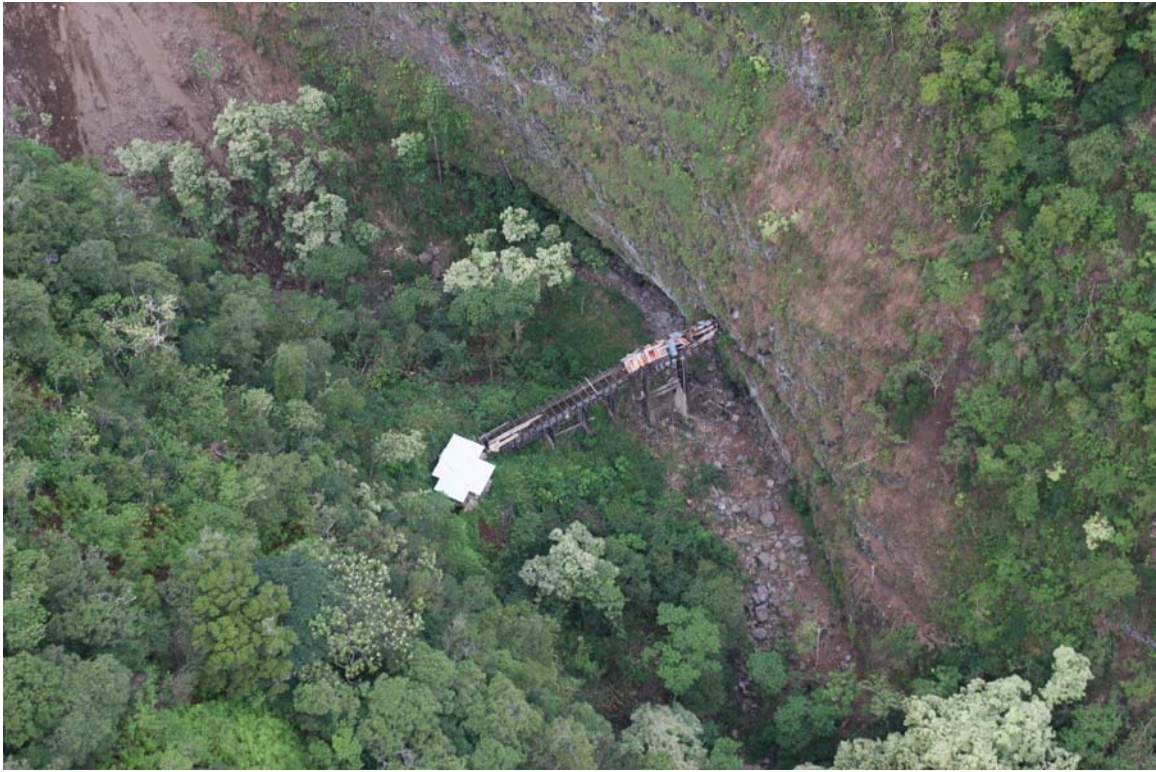
19.11. Aerial view of the irrigation flume, left unharmed by earthquake and rock falls, near a debris pile at the base of the cliff (see photo 19.10 (jpk6025)) in Pololū Valley (view to the west). USGS photo by E.L. Harp, 11/8/2006 (elh1253).
